CI Update: Walk 419

Ci Spotlight

StandardAero

Component Services

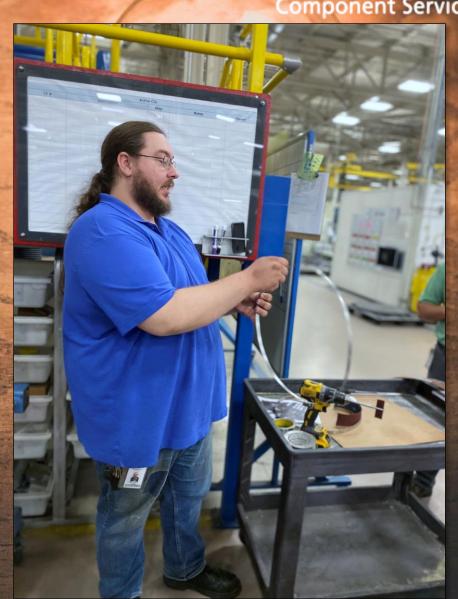
R&D Cell CI#19406 PW4000 Shaft Fixturing

Current state: When using butterfly polishing, damage occurs to the diameter.

Future State: Design a pragmatic and repeatable fixture for the PW4000 shaft.

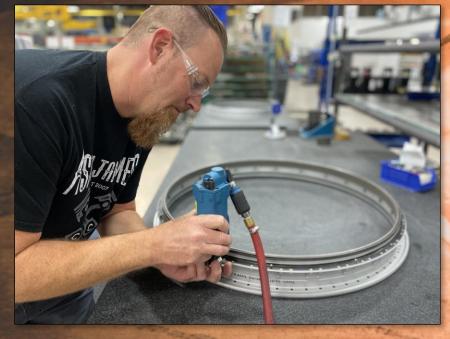
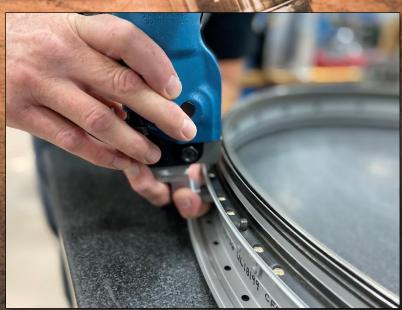
Large Cell CI #20307 Nuts

Current state: Torque process causes nuts to twist and become un-seated during shank nut installation.

Future State: Use a pneumatic rivet squeezing tool to reduce rework for non-seating shank nuts.

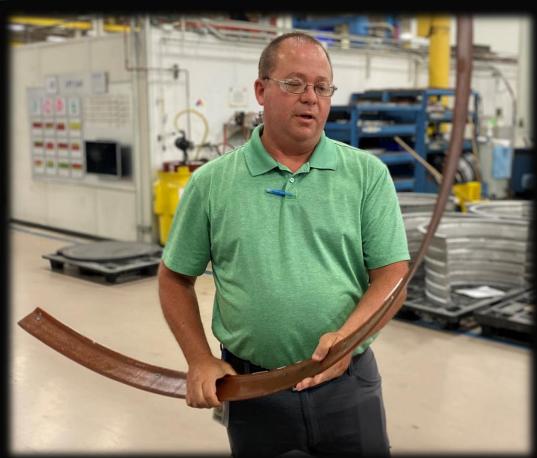
R&D Cell CI #20488 CFM56-5B Abradable Liner Locating Fixture

Current state: Existing sheet metal tool is unable to hold the abradable liner within the dimensional tolerance during curing.

Future State: Manufacture tooling using Cytec LTM10 tooling prepreg on the FWD and AFT side of the abradable shroud case surface.

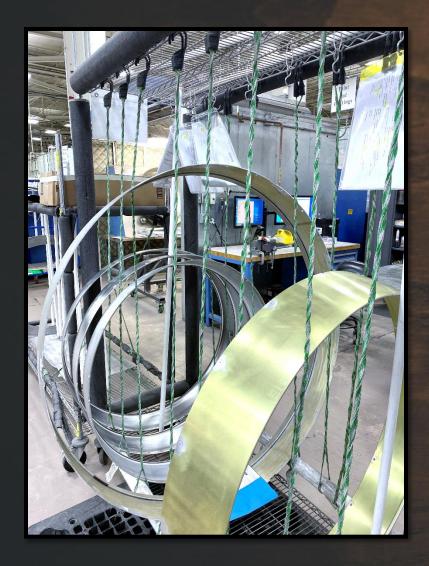
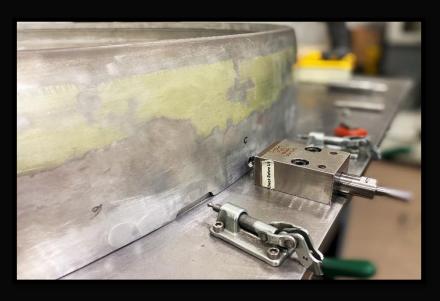
Composite Cell CI #20498 Fairing Locating Pin

Current state: Multiple reworks due to bolt holes being drilled off-center or oversized.

Future State: Designed pins to fit into the bolt hole to ensure accuracy.

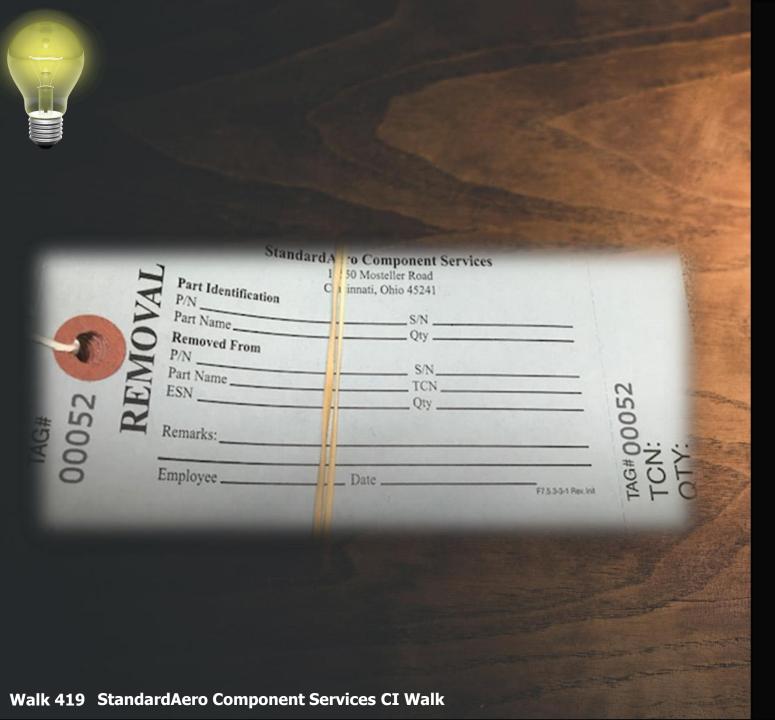
Small/Medium Cell CI #20294 Tracking Removed Parts

Current state: Parts are not being returned to the customer with the repaired component/hardware within a timely fashion.

Future State: Created a tag system along with sequence notes to serve as a reminder for the parts that need to be returned.
